Technical Report

Damaged Digi-Shock G Impact Recorder - Data Extraction from Memory Chip

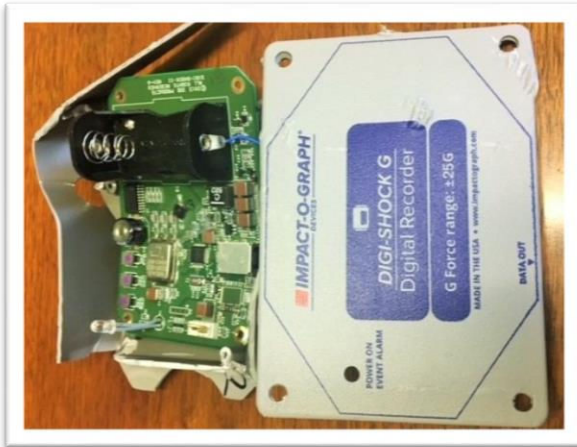
Digi Shock G cover (little damage) but case and circuit board extensive damage

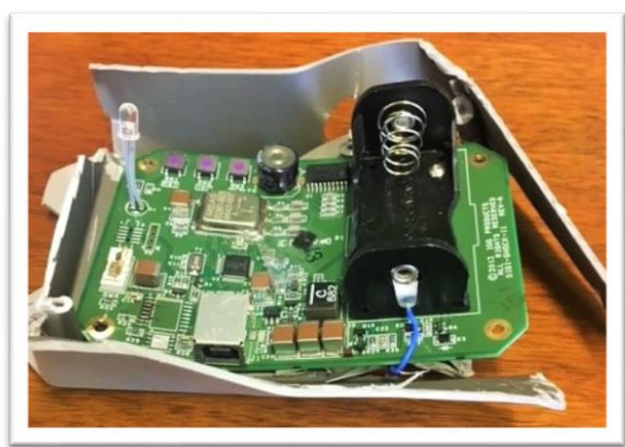
Device case damaged showing bent circuit board. Battery case cracked broken.

Normally we would need the PCB to be able to power up and then we have some tools to extract data from the memory chip. In this case however the PCB was cracked, the battery case was broken, and the tamper switch was destroyed. The damage experienced by the PCB was not repairable and the unit was not going to power up anymore.

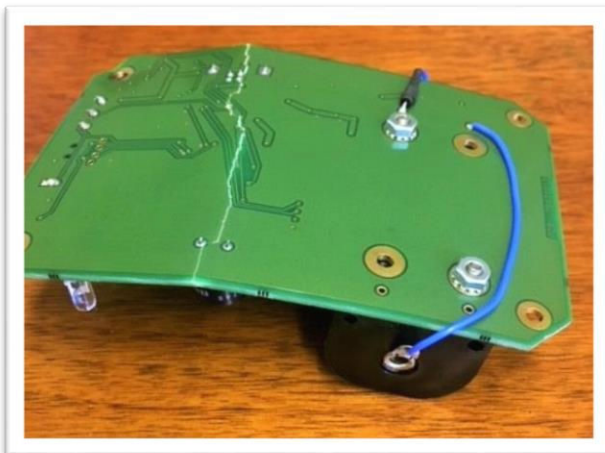
Removed circuit board showing crack causing the board to be non-functional.

What we were able to do for Graphic Packaging was to remove the memory chip from the damaged PCB and install it into a good PCB and then read the results.

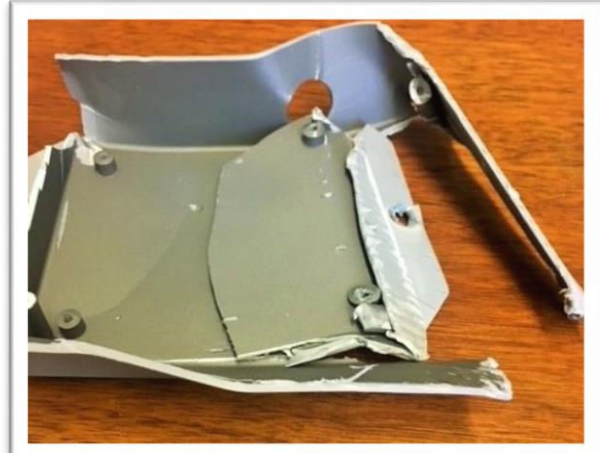
Damage to the empty case.
