Technical Report

Damaged Digi-Shock G Impact Recorder - Data Extraction from Memory Chip

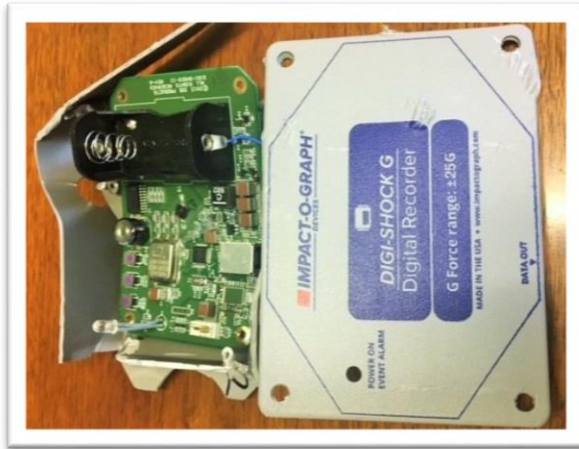
Digi Shock G cover (little damage) but case and circuit board extensive damage

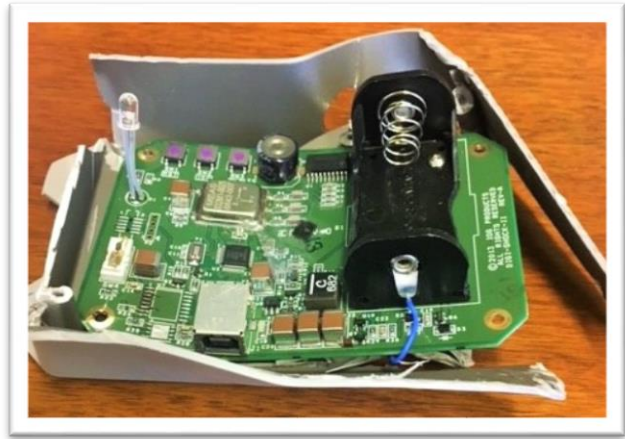
Device case damaged showing bent circuit board. Battery case cracked broken.

Normally we would need the PCB to be able to power up and then we have some tools to extract data from the memory chip. In this case however the PCB was cracked, the battery case was broken, and the tamper switch was destroyed. The damage experienced by the PCB was not repairable and the unit was not going to power up anymore.

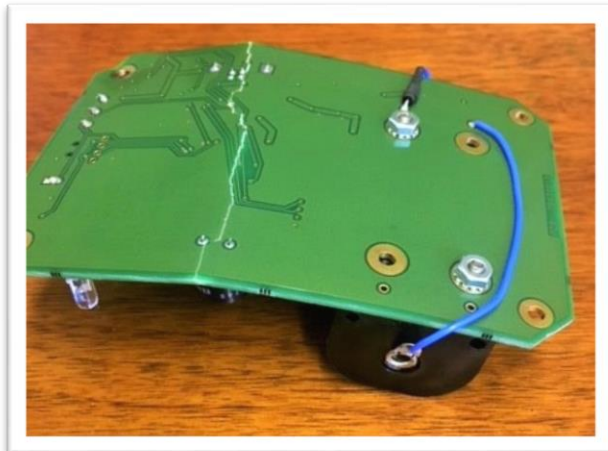
Removed circuit board showing crack causing the board to be non-functional.

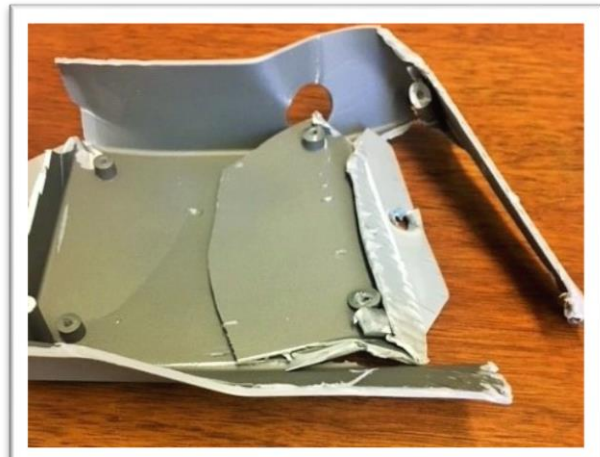
Damage to the empty case.
